**PENNSYLVANIA  
ID NO. PA.00688**

# **LOWER TUMBLING RUN DAM**

## **PHASE I INSPECTION REPORT NATIONAL DAM INSPECTION PROGRAM**

**AUGUST 1978**

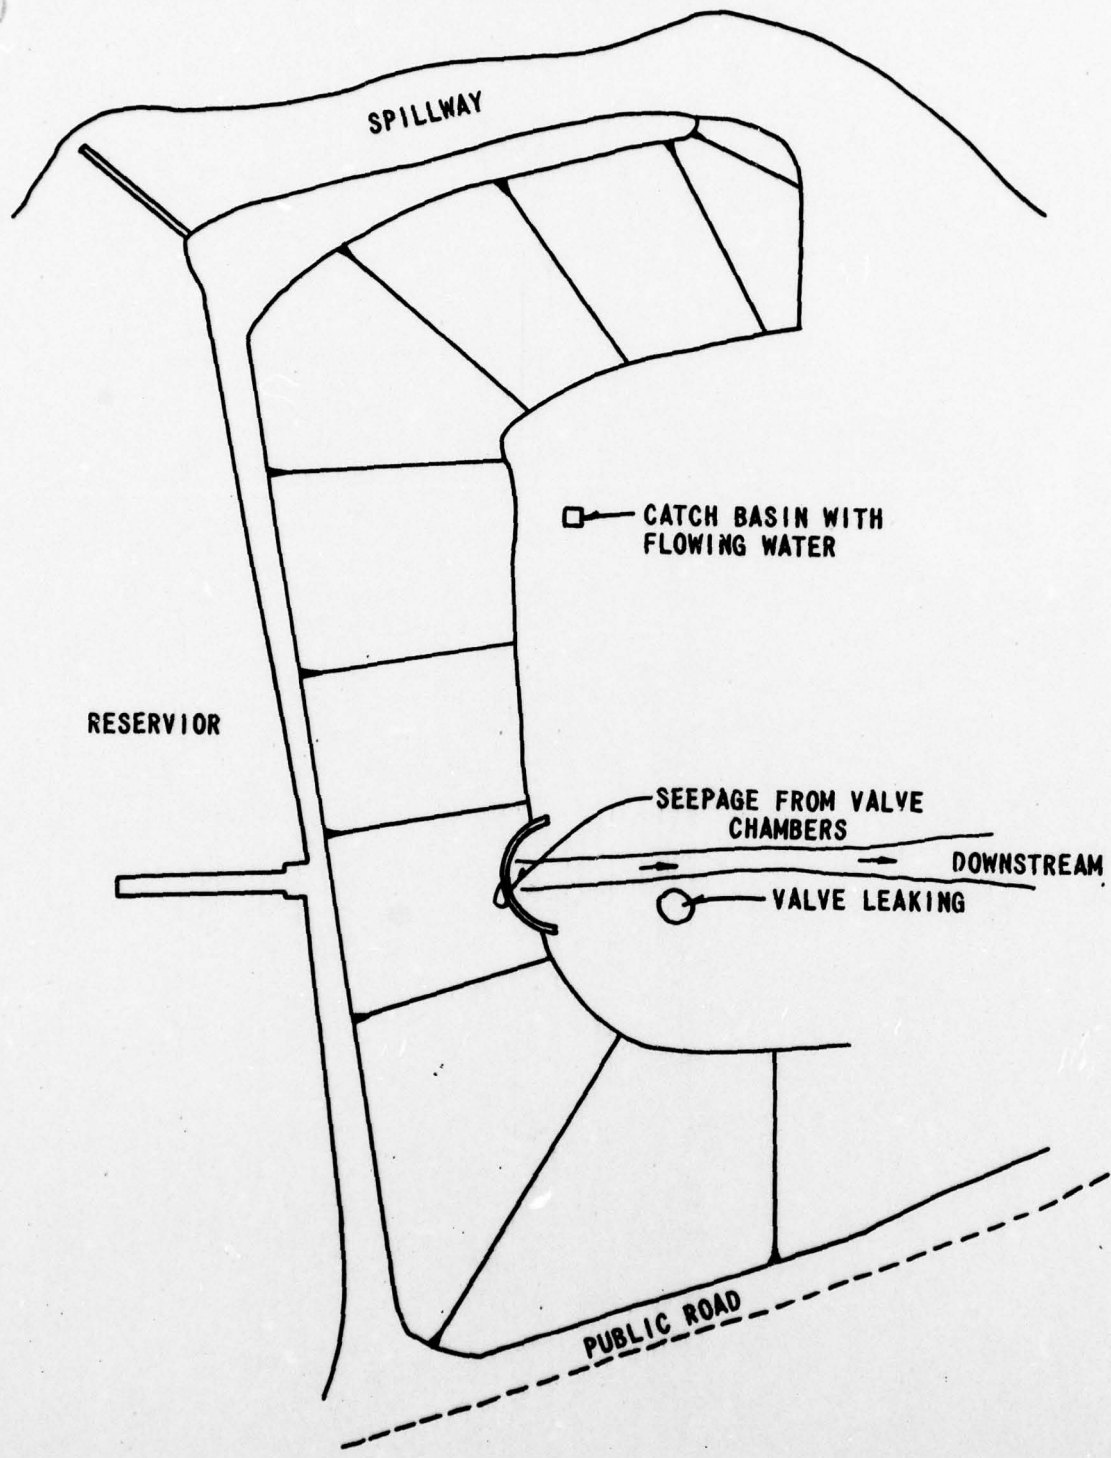
SHEET 5a OF 11

A slight quantity of seepage was observed through the valve chamber located at the downstream toe on the right side of the dam. Seepage was also noted through an observation well at the toe near the left abutment. This flow is probably the seepage through the French (tile) drain system reported by Gilbert Associates, Inc., in 1967. Location of the observed seepage is shown on Sheet 5a, Appendix B.

Yes. See sheet 5a of 11 for details. A slight amount of seepage was noted at the valve chamber. A catch basin was also observed near the downstream toe which contained water and appears to be connected to a french drain system.

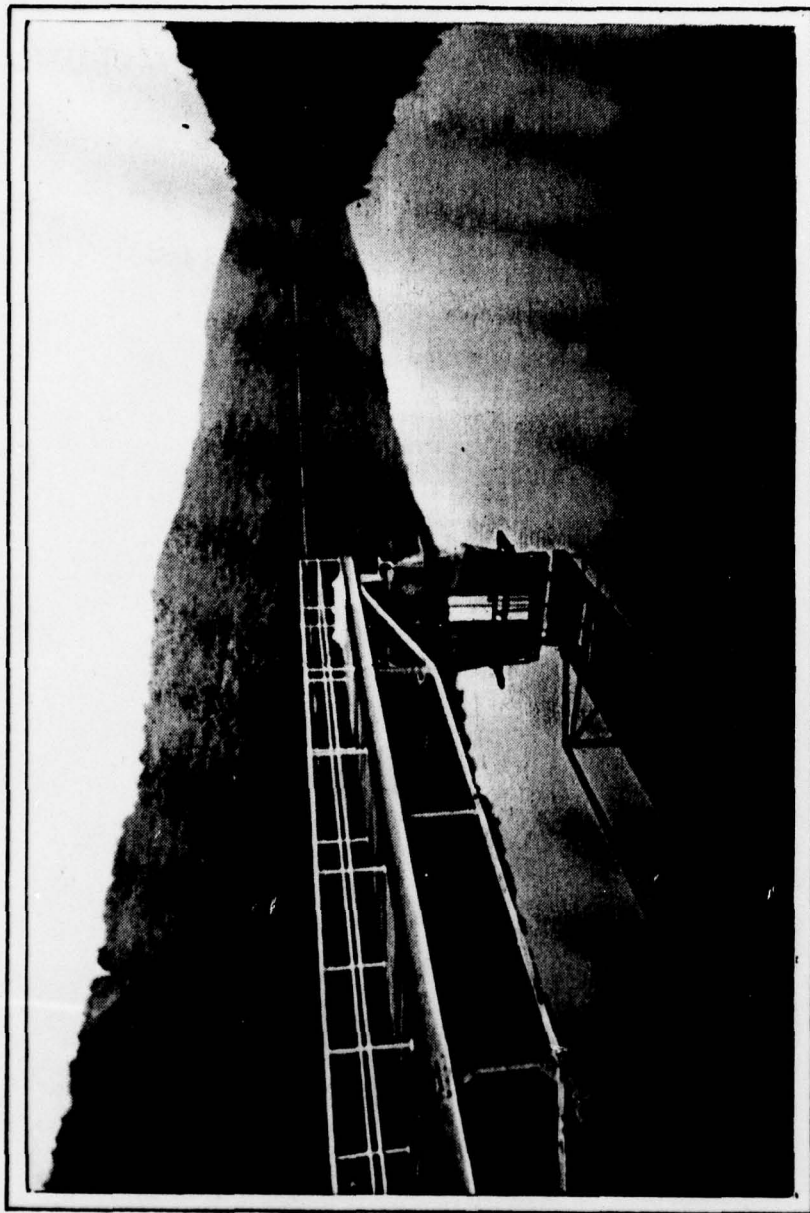
PHOTOGRAPH NO. 1

1. Outlet Works. The intake structure and cast iron pipes were submerged during the visual inspection and could not be inspected. The access bridge to the intake valves consists of a steel frame structure with wood planking. The concrete supports of the bridge were noted to have a number of cracks, but appeared to be stable. It was reported by Mr. Charles Feindler, Borough Manager, that the intakes for the vertical riser pipes are approximately 7, 14 and 22 feet above the base of the intake structure. They are connected to three 12-inch diameter cast iron pipes. See Plate 5 for details.

OUTLET SUPPLY CONTROL TOWER AND  
ACCESS BRIDGE.

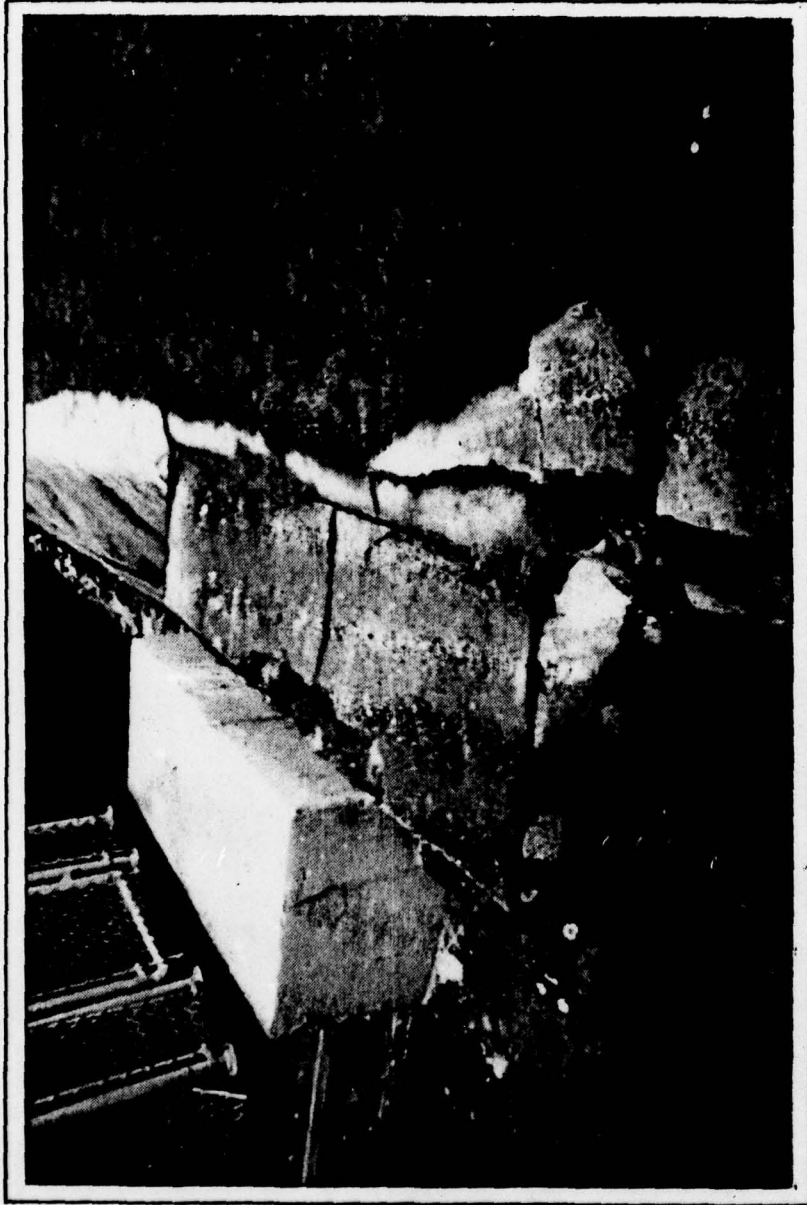
VIEW OF ACCESS BRIDGE ABUTMENT ON  
EMBANKMENT. NOTE CRACKS AND OVERALL  
DETERIORATION.

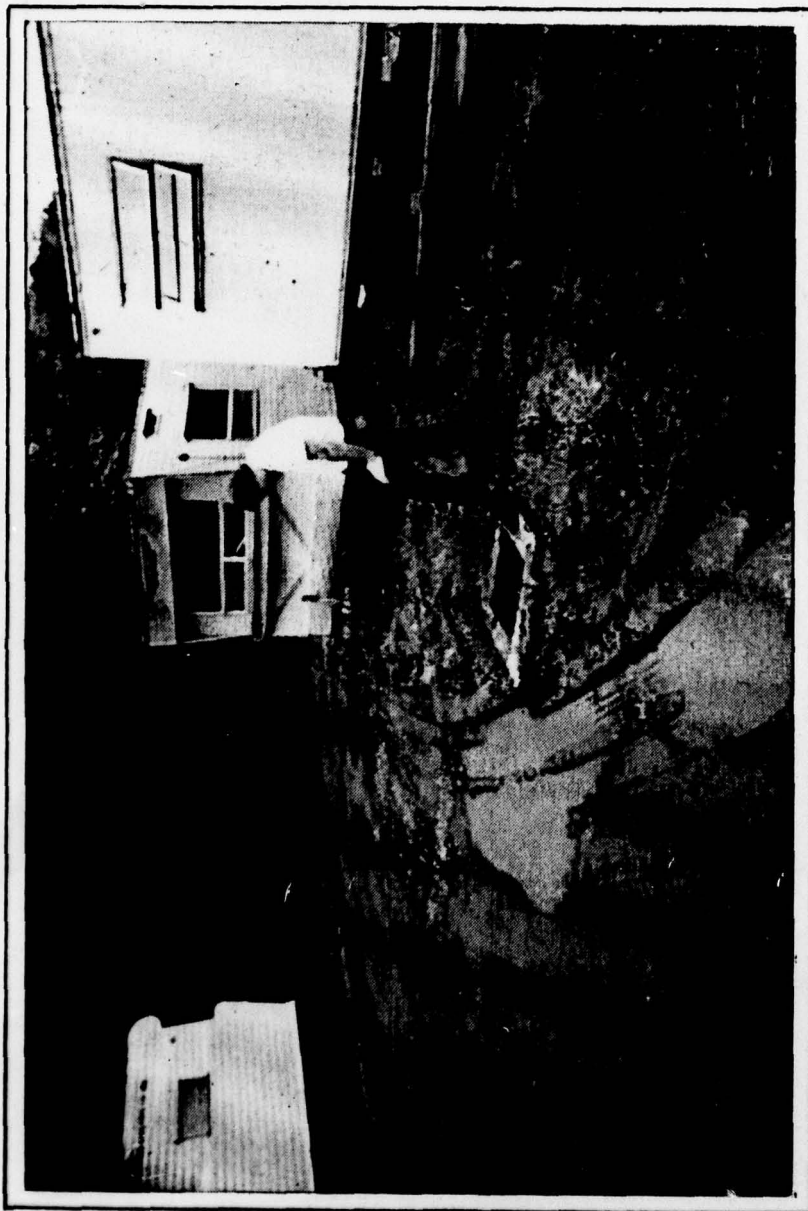
PHOTOGRAPH NO. 12

Yes. The french drain below the dam toe is presently covered and serves as a parking area but there are two existing brick access boxes, catchbasins, where the seepage can be observed. The flow was clear.

ACCESS BOX TO TOE DRAIN SEEPAGE.  
THE EMBANKMENT IS ON THE LEFT  
OF THE PHOTOGRAPH.

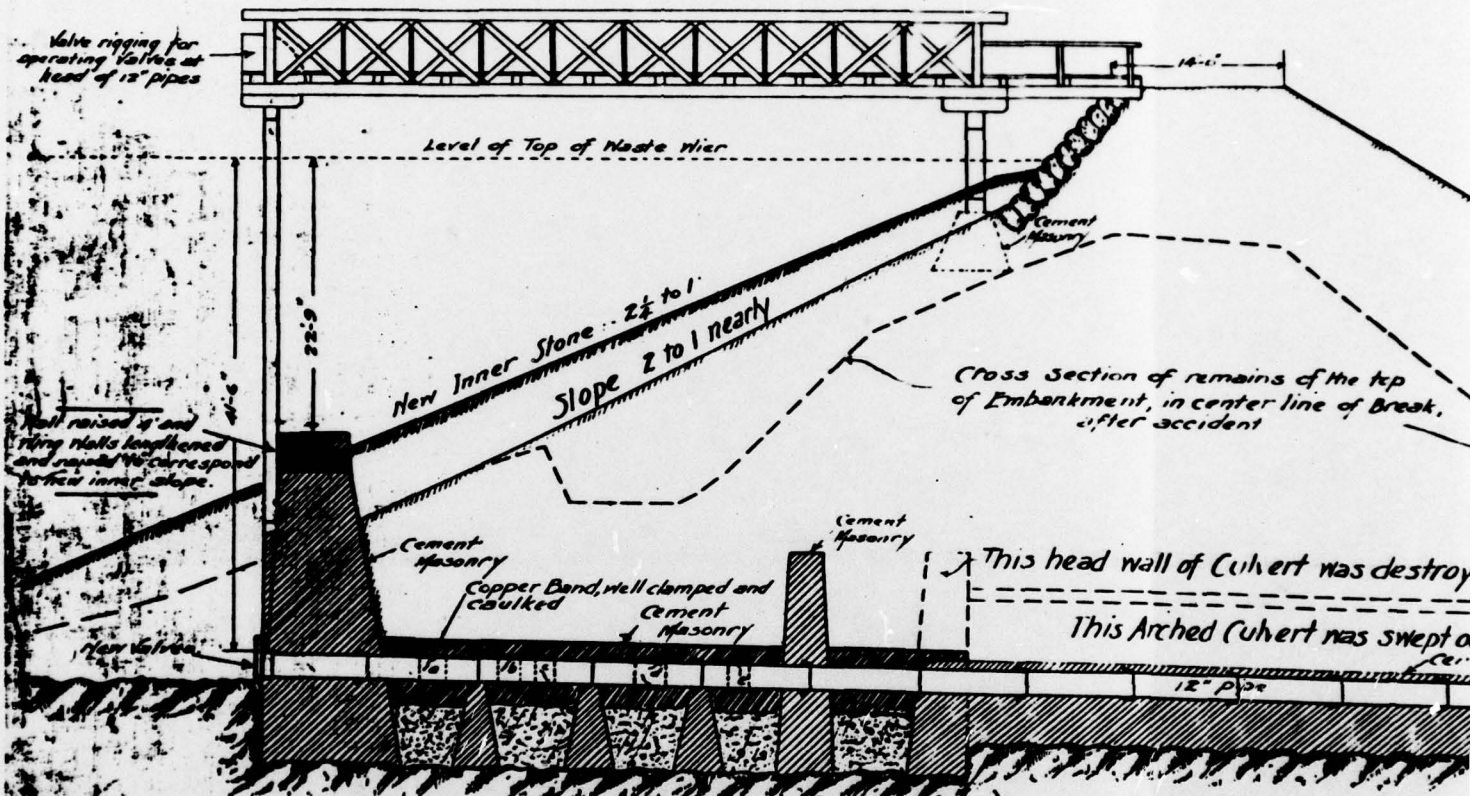
Before 1869, the water supply pipes were always under full hydrostatic head. These pipes apparently cracked and the resulting leakage was large enough to cause piping and eventual embankment failure in 1869. As shown on Plate 4, the top of the dam dropped 10 feet. The pipes were repaired, encased in concrete for part of their length, and the valves moved to the upstream end of the pipes.

There were a number of cracks in the pipe (a, b, c, d, e) which were banded, clamped and caulked in the very best manner before building the cement wall around the pipes.

Underneath the pipe was soft Clay puddles - this is now dug out 2 ft. below pipes and under this for .5 ft. more in depth the Clay has been consolidated to a good building foundation by ramming pebbles and broken stone and working it down with an iron puddle bar. Pipes are now covered with cement wall shown in Red.
